# Shift Indicator Panel

## Adjustment

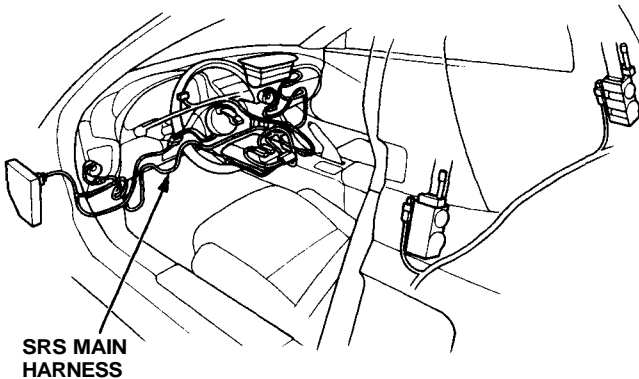
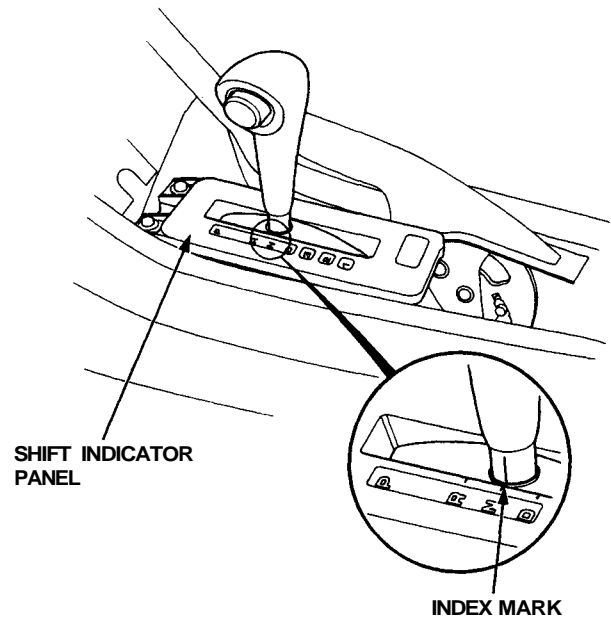
1. Check that the index mark of the indicator aligns with the N mark of the shift indicator panel with the transmission in NEUTRAL.
2. If not aligned, remove the center console panel (see section 20).
3. Remove the shift indicator panel mounting screws and adjust by moving the panel.

NOTE: Whenever the shift indicator panel is removed, reinstall the panel as described above.
